# Bridge 1

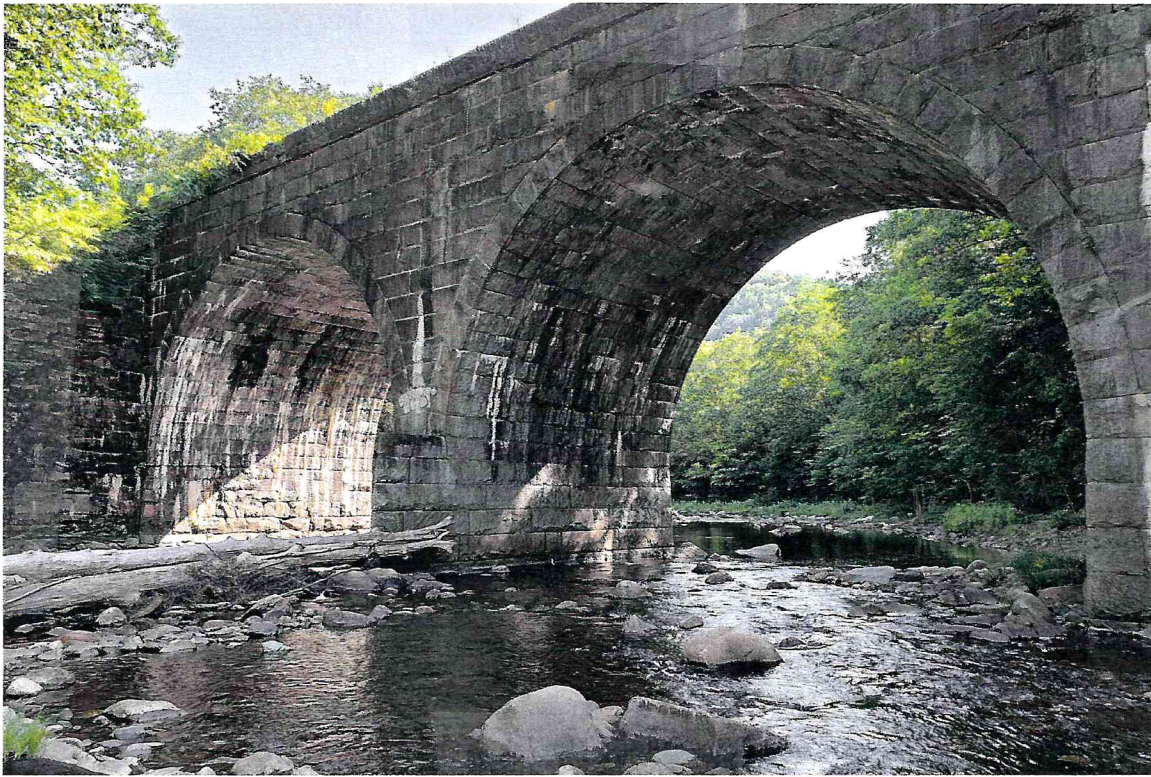
**Bridge 1:** 45 feet above the river; in use; property of CSX. The only dual arch. In lieu of a single keystone, there is a cluster of five stones, slightly taller than the surrounding ringstones on the apex of each arch. Oddly, this trait is shared by the only other example still in use by the railroad. Of course, this raises the question: How many variations on the missing five bridges are we now unaware of?

**Bridge 1:** In use, has a 12" stone on the bottom and a 24" stone on top. Here capstones employed as intended, to contain the track structure and ballast. 36" total

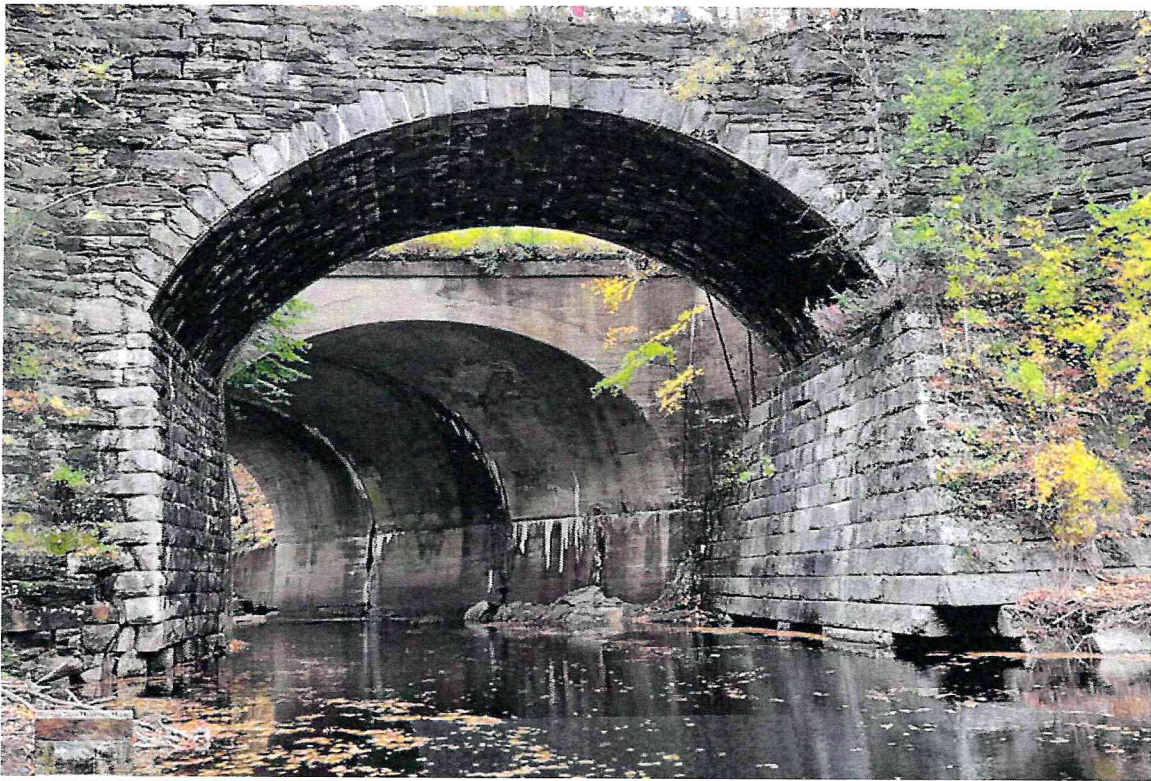
## Bridge 2

**Bridge 2:** 55 feet above the river; abandoned; property of CSX. This is the only surviving bridge on which the ringstones have pointed tops, rather than a circular contour. It is the most endangered arch, because it has no chance of restoration due to its ownership and location across the mainline. Sometimes referred to as the 'Gator Tail' or the 'Orphan' Arch. This bridge shows the most significant structural deterioration of any.

**Bridge 2:** The only abandoned bridge with an intact parapet wall, sans track and ballast. Here, the stones measured 14" and 23" respectively. **37" total**

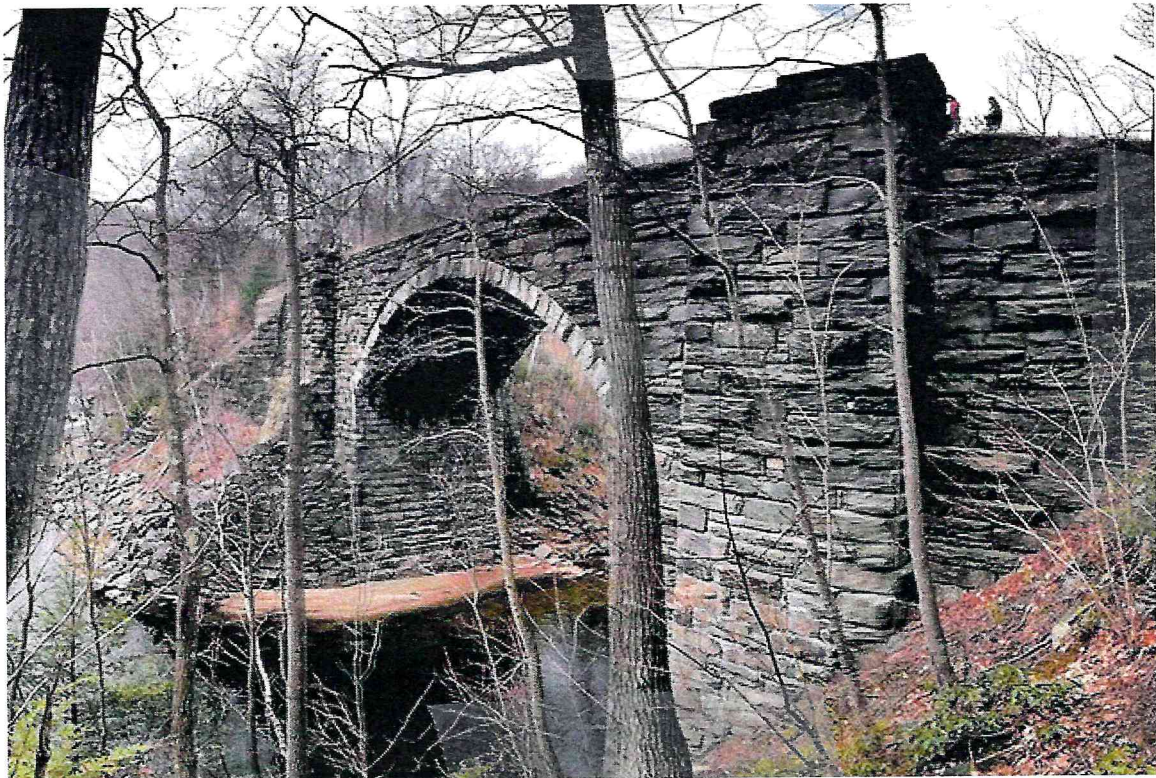
## Bridge 3

**Bridge 3:** 65 feet above the river; bypassed in 1912; now the property of MA Fish & Wildlife; a part of the Walnut Hill Conservation Area, the hiking trail puts visitors on top of it. This bridge and the one following were bypassed by the NYC in 1910 when realignment eliminated two sharp curves. Both bridge 3 and 4 span 55 feet. However, due to the location of underlying bedrock, they are shaped quite differently. Bridge 3 is an elliptical arch. This form directs stresses to the sides, where there is a solid foundation.

**Bridge 3:** This bridge differs from the first two in that it has a buttress tower on each corner. Tower stones are the only ones remaining above the gradient. They are placed 12" on the bottom and the 24" on top. Photos taken before capstones were pushed off by vandals (see illustrations) confirm that the placement was reversed on the stones forming the parapet walls. Those courses featured the 24" stones on the bottom and the 12" on top. Observing existing conditions, we would never know this. This arch, at the crown, is only five feet thick. Random stones measure in at 63" and 53" long. **36" total**

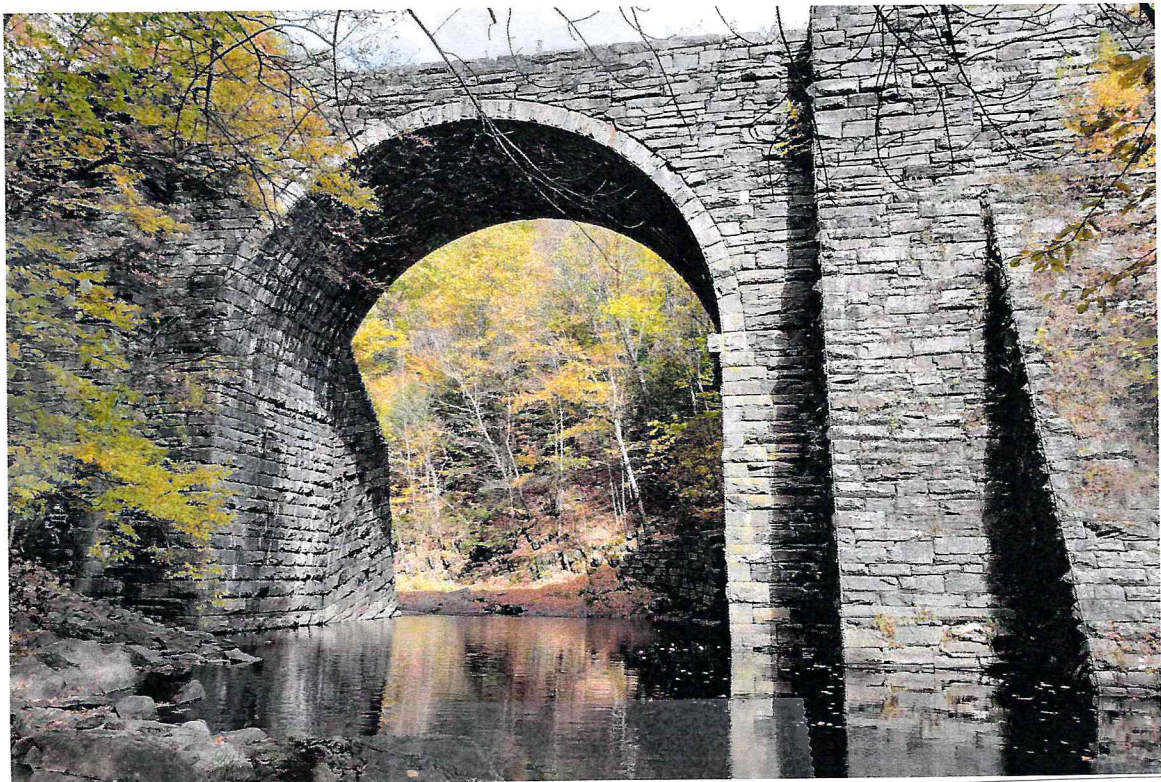
## Bridge 4

**Bridge 4:** Here are more variations, including the use of face stones. As you approach, in reality on top of a long fill, there are stones measuring 16" on the bottom, and 9" on top. Random checks of both courses reveal a 68" length. However, as you cross the bridge, the stones remaining from the parapet wall uniformly measure 17" high on top of each

other. All is not as it seems, however, as the bottom row utilizes face stones, so in reality, there are two narrow stones on the bottom with a single full-sized course on top.  
**34" total**

**Bridge 4:** Property of MA F&W; trail crosses it. Like Bridge 3, a 55 foot span, this arch is circular in shape, as secure bedrock is situated directly below. (See drawings comparing bridges 3 & 4 in the illustrations). In addition to its 70 foot height, this leviathan sports spectacular wing walls, some curving gently up to 300 feet through the woods, and buttresses that slash at multiple angles down into the river.

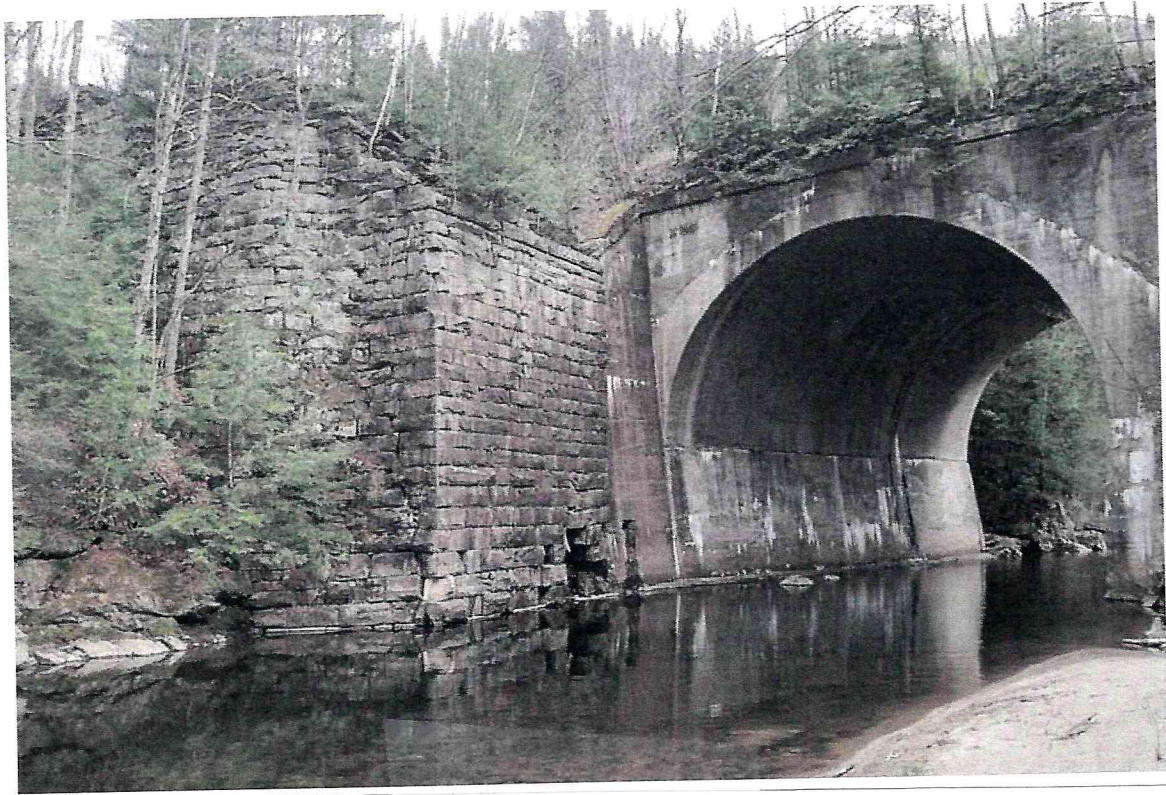
## Bridge 5

**Bridge 5:** Partial; ownership unclear as it sits near the CSX / Commonwealth property line. Was about 70 feet above the river. Also unclear is what destroyed this bridge. The supposition is that it was dismantled to make room to construct the forms for the concrete when building the concrete arch just upstream. It consists of side and wing wall to the spring line, on the southern bank. On the opposite bank, are the two outer walls and west abutment. This provides a matchless interior view of stone masonry arches. A treasure for students of engineering. Visually pleasing singular feature of this ruin is a curved integrated buttress on the wing wall.

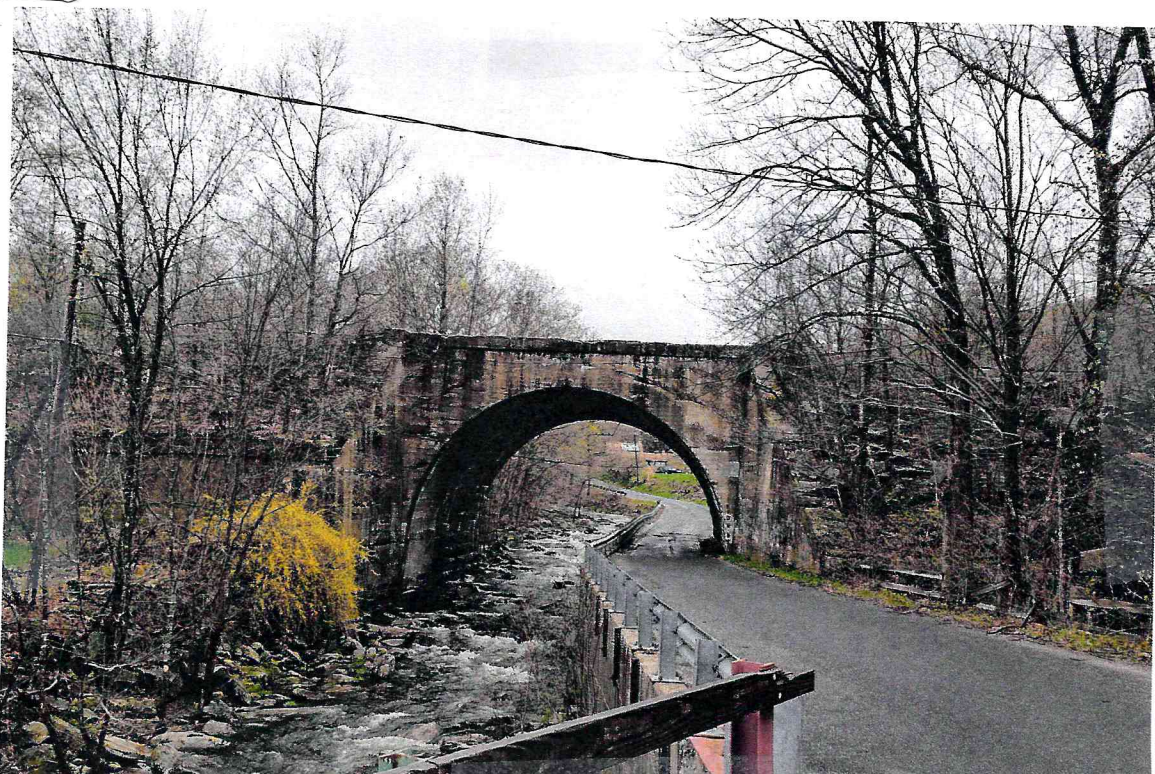
## Bridge 6

**Bridge 6:** This bridge was widened to three tracks in 1910, adding a south side of poured concrete. When the line reverted to two tracks, the railroad utilized the south lane and the former middle lane, leaving the northern parapet stones exposed as they would have been on an abandoned arch or as bridges were configured in the first decade of operation when the line was single-tracked. None have been knocked off, probably due to adjacent homes and the road beneath the bridge.

Capstones measure 11" on the bottom and 23" on top. In another unique variation, bottom stones here are wider than the ones in the top row creating a visually pleasing border detail. **34" total**

**Bridge 6:** 45 feet above the river; in use; property of CSX. This bridge shares the 5 stone cluster at the top of the arch with bridge 1. This is the only bridge that does not cross the Westfield River. Rather, it crosses Factory Brook, a tributary, about 100 yards north of it's confluence with the Westfield. As a result, it lies wholly within one town, Middlefield. It shares this also with the first arch; wholly in Chester.

road beneath it, in addition to water. This bridge was widened to three tracks in 1912. As a result, the south face has been rendered in concrete. Its original southern stone visage survives on an early post card which incorrectly identifies Factory Brook as the Westfield River.
